# Ductless Spray Hood HEPA Filter Longevity Spray Test

November 2008

**Sentry Air Systems  
6999 W. Little York Rd, Suite P1  
Houston, TX 77040**

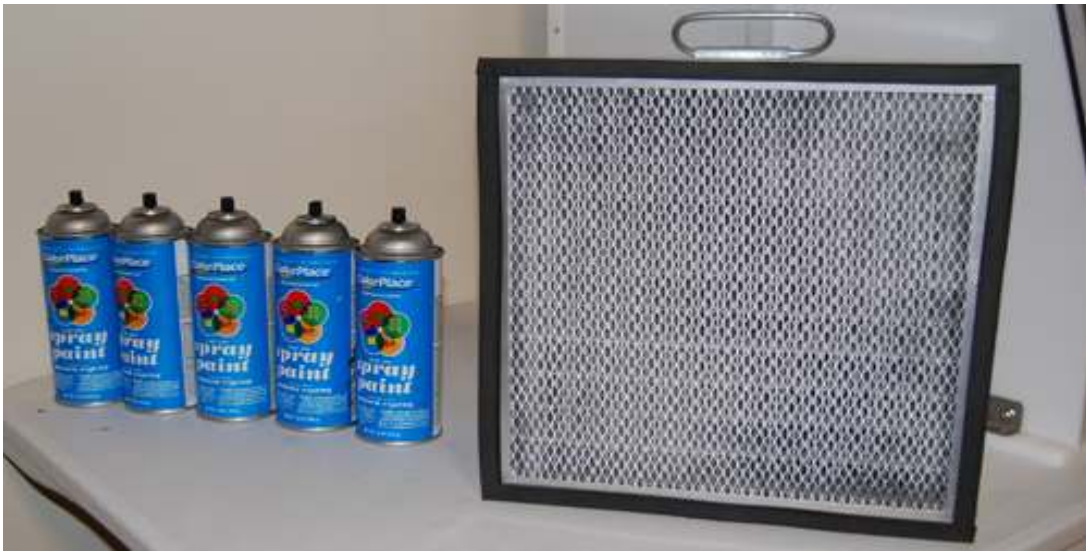
## HEPA Filter Progress

5 Cans – 135 FPM

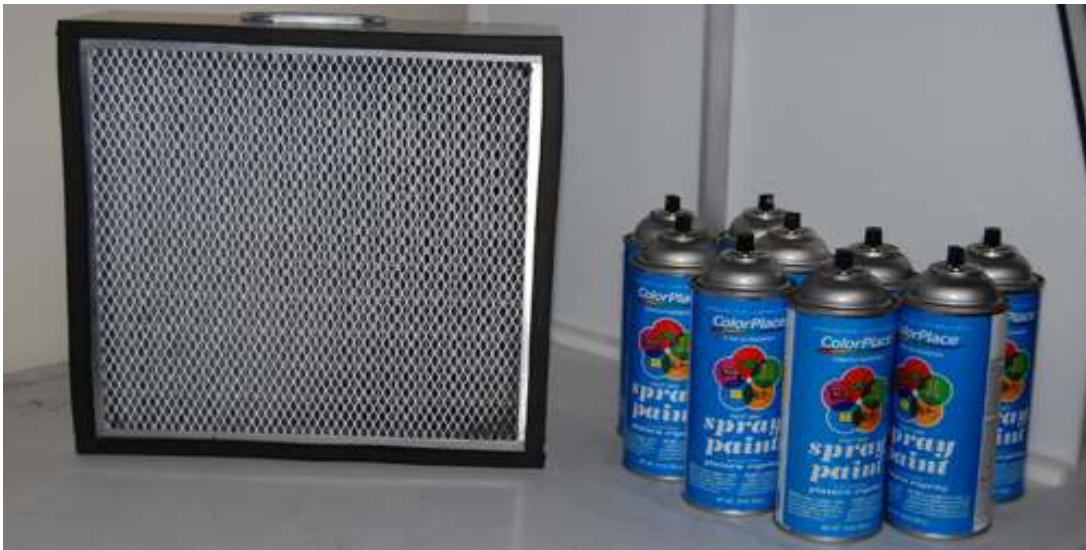
9 Cans – 130 FPM

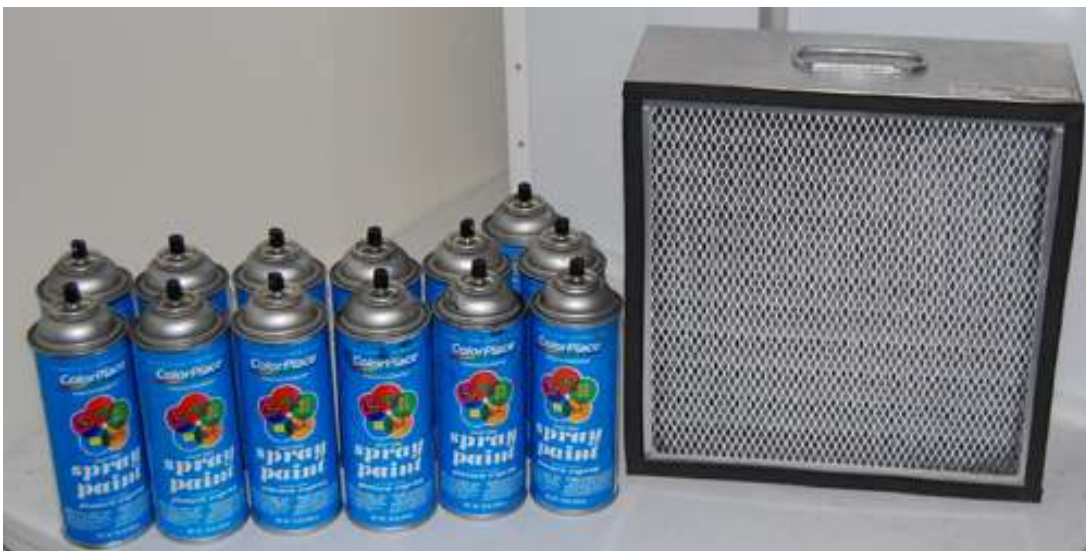
13 Cans – 137 FPM

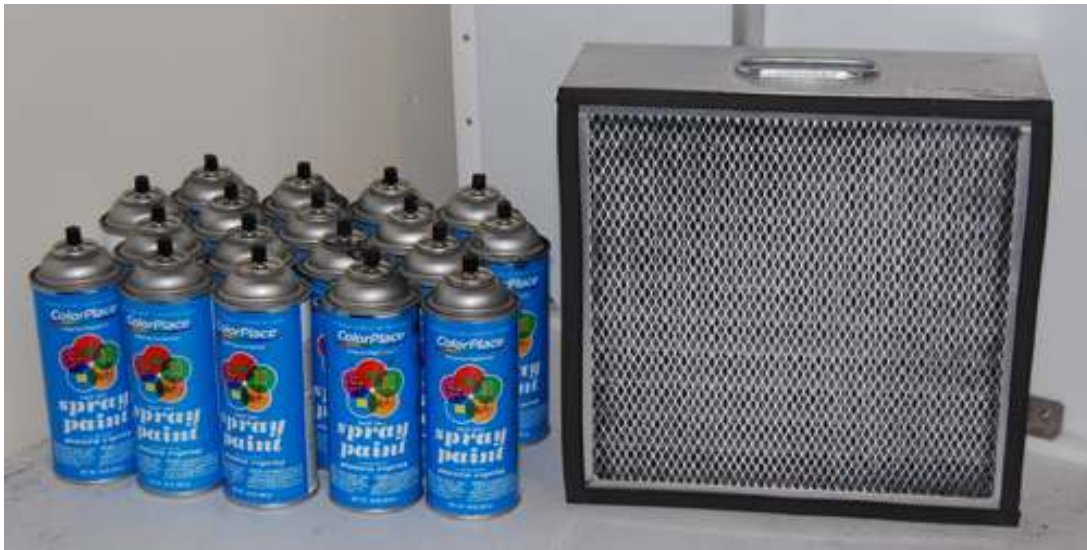
18 Cans – 140 FPM

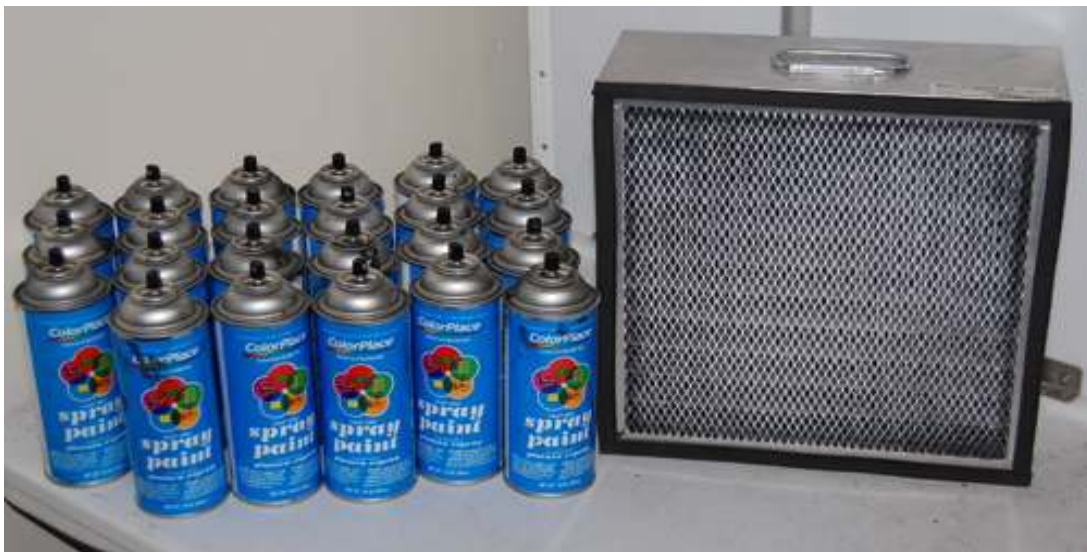
23 Cans – 138 FPM

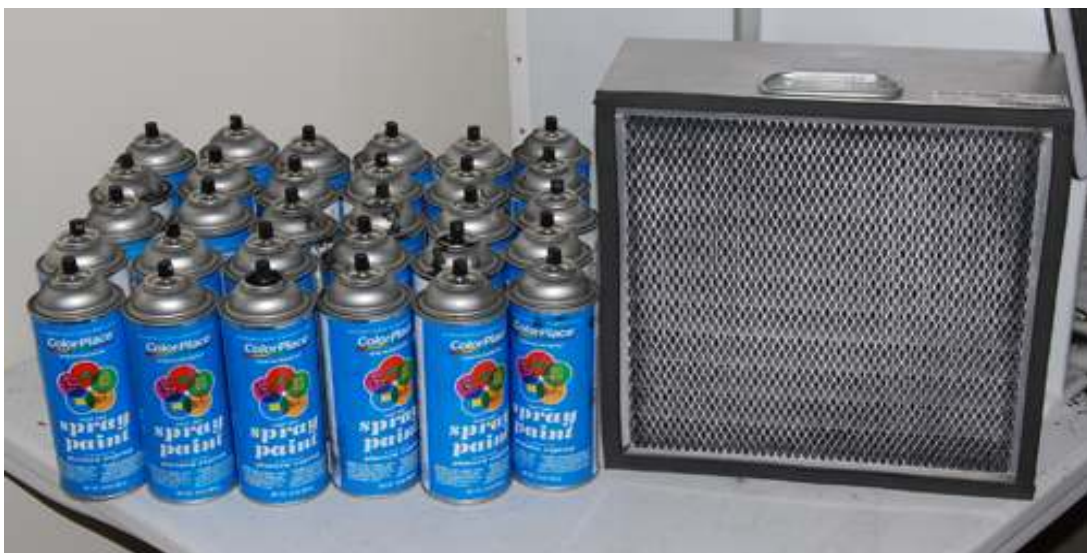
30 Cans – 135 FPM

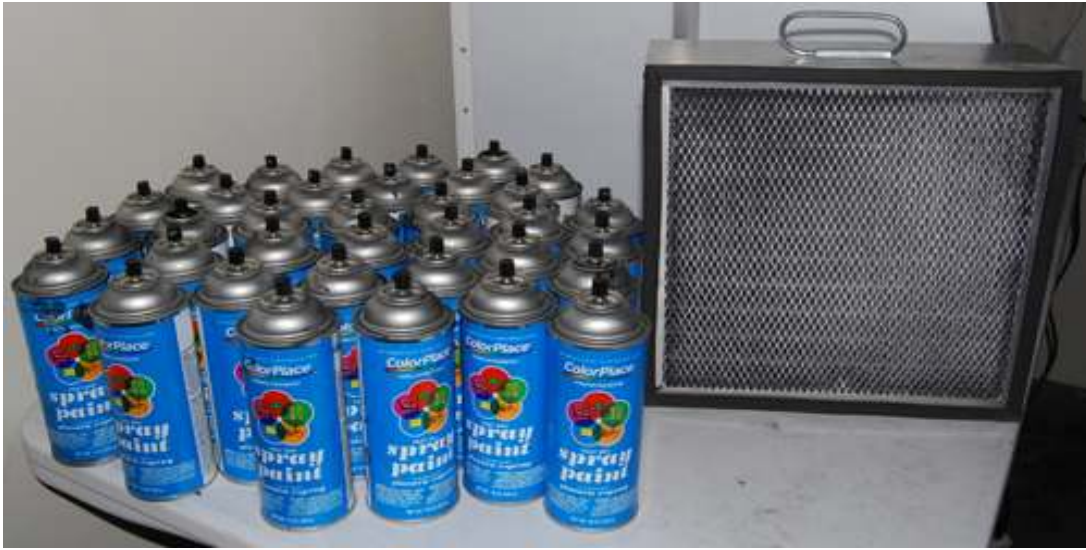
35 Cans – 135 FPM

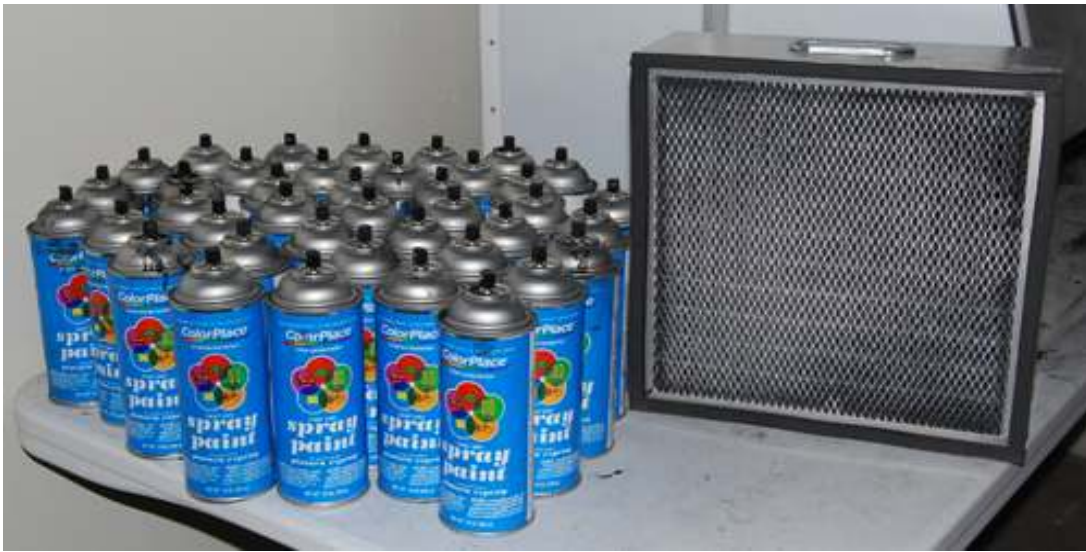
40 Cans – 133 FPM

***Post- Test Results: After 40 cans of spray paint, airflow measurements were unchanged with an error rate of  $\pm 5$  FPM.***
